Quantifying pumping energy efficiency (aka sustainable pumping) in an irrigation system has long been understood to be made with a simple pump test.

These case studies have been compiled as living proof of the feasibility and practicality of identifying (or incorporating into new systems) up to 50% hydraulic savings from pumping system energy audits.

### Case Study 1: Windsor NSW, Turf farm 1

## Case Study 2: Windsor NSW, Turf farm 2

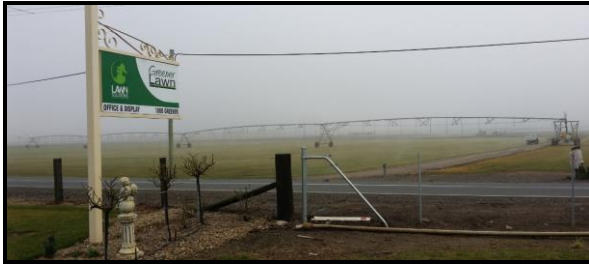
A new 203m long Lateral Move (LM) irrigator had recently been installed on the privately owned farm. A belt driven 45kW electric pump delivered 28 l/s from the Hawkesbury River to the LM approx. 1000m away via a 150 PVC pipe plus 130m of 100 lay flat hose.

*Lateral Move irrigator on the turf farm*

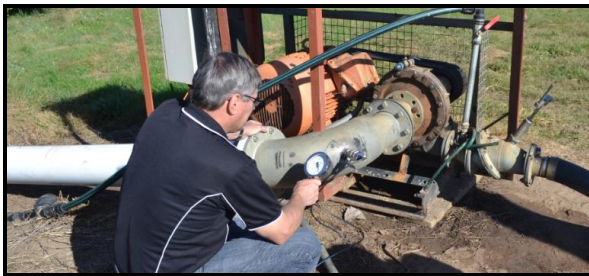
*Testing the pump*

It was found that the pump was running left of BEP at 65% and the 150 PVC rising main was fouled with iron hydroxide unbeknown to the farmer, causing the extra 36m of friction loss greater than new pipe friction.

The pump losses accounted for 13% or \$1,800pa.

Replacing the 1000m of pipe with new 150 PVC and replacing the pump with a lower head direct drive 30kW pump with correct BEP would have saved \$7,700pa, or 56% of present pumping costs.

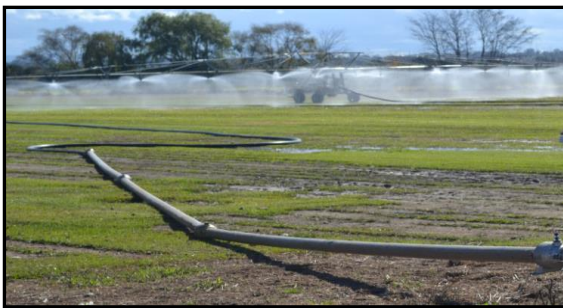
*Soft Hose Boom, with 200m ft of 75 layflat hose*

The soft hose boom above was the emitter in this audit. Water was supplied with 200m of 75 lay flat hose. Friction across the layflat hose was measured at 28m. A 90 hose would have had only 10m loss.

It was found that the layflat hose supplying the boom irrigator was undersized and incurring a 28m head loss, 18m over and above achievable losses.

Assuming the layflat hose hydraulics is restored with a larger hose, and the pump was replaced with the correct size and BEP, the system would then run at \$4,330pa and \$44/ML, a saving of \$6,370.

Had a pump test only be carried out here, a further 33% energy savings (\$3,500pa) would have been overlooked from upgrading the layflat hose from 75 to 90mm.

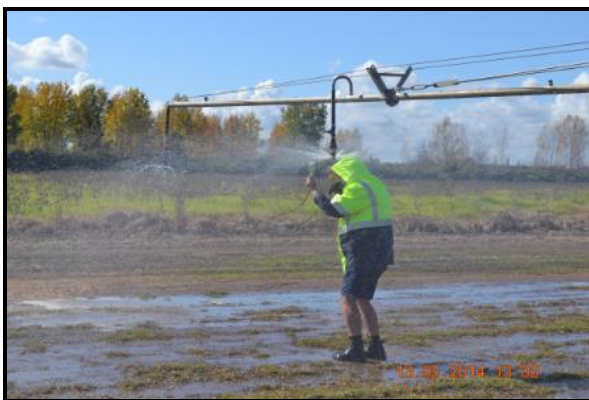
*Measuring residual pressure on the Boom.*

In addition to the large layflat hose friction losses, there was excessive residual pressure on the Boom, and the pump was considerably down in performance and running well off BEP, resulting in a combined operating cost of \$108/ML.

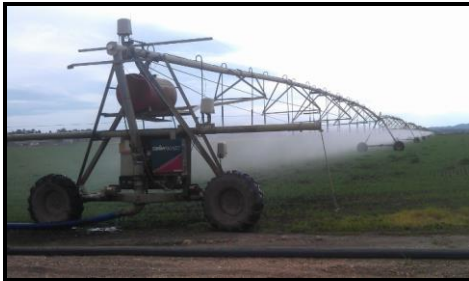
Checking end of LM residual pressure

Excessive residual pressure (25m) was found at the end of the LM, plus high hydraulic losses on the layflat hose, and the well maintained 35yr old pump, in otherwise good condition, was running left of BEP.

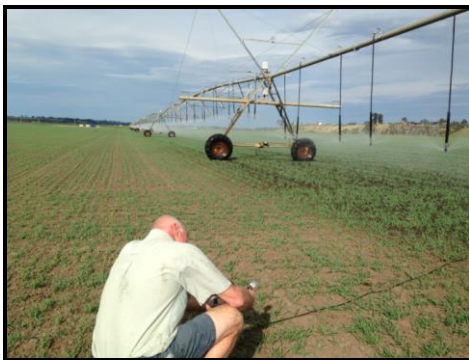
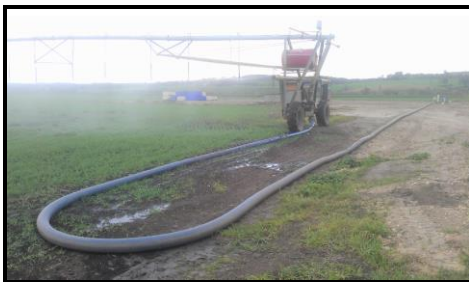
The Lateral Move was supplied with 100m of 4" layflat hose. Misting was evident at the nozzles, potentially indicating high residual pressure.

However, the residual pressure at the end of the LM was excessive and could be reduced by 10m.

In this case, a trimmed impeller would achieve the required pressure reduction, with minimal cost.

An impeller reduction would cost about \$1000 in labour, resulting in a ROI of about 1.0 yr.

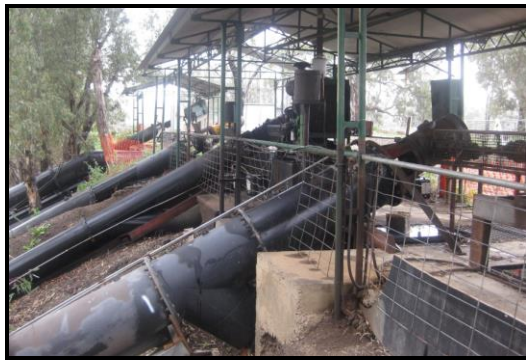
*One of the submersible flood pumps audited for pumping energy efficiency.*

It was found that the pump efficiency was well down, in addition to running off BEP.

Once overhauled, this pump would operate with a \$9,270pa electricity saving.

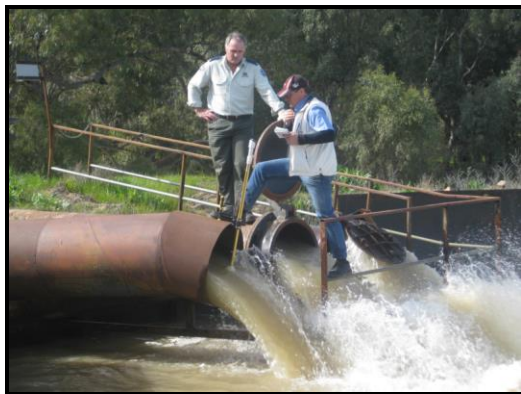
*Measuring flow at the flood irrigation site audit. A stream velocity meter was used to measure a water velocity profile, hence flowrate, since the station's propeller actuated flowmeter was considered inaccurate.*

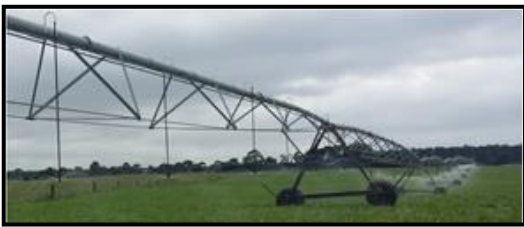
The audit measured pump efficiency plus friction losses across each major pipe and irrigation equipment sector. The pumped system had 470 ML/yr usage, approx \$35,885/yr electricity cost at ave 20c/kWh and pumped head was 63m.

The residual pressure at the end of the CP was 7m.

Replacement of the 150nb PVC pipe with 200nb would result in only 4m head loss, a saving of 21m friction.

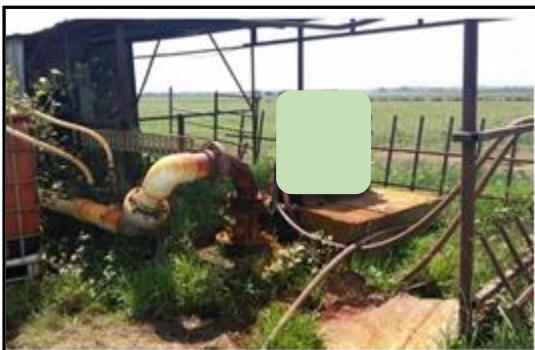
*Photo below showing well head*

The old and tired submersible well pump was down 10% on efficiency and running well to right of BEP, at 57% effy.

To potentiate the savings, the pump needed to be changed out to a lower head pump with the same output 36 l/s, but with the correct BEP.

The pump was downsized from 55 to 37kW at 36 l/s, at the same time the pipeline was replaced with a 200nb PVC.

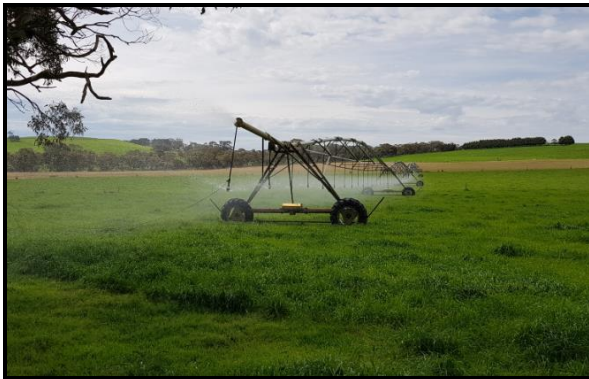
An 8 yr old 190m long Center Pivot (CP) irrigated mixed pasture on the dairy farm. A 15kW vertical multistage pump on a VFD lifted 16 l/s gpm, with a TDH of 53m to the CP approx 520m away via a 150nb PVC pipe.

The CP operated over a considerable land undulation, ranging from 28m lift at its highest, to 2m lift at its lowest, making an average lift of 15m.
